Property Inspection Report

123456 Mayberry Lane, Mayberry, Illinois 60001 Inspection prepared for: Steve Savas Real Estate Agent: Best Realtor in the area - Top notch realstate

> Date of Inspection: 11/13/2015 Time: 2:30 pm Age of Home: ~51 years old Size: ~2,000 sq. ft. Weather: 45 degrees and sunny

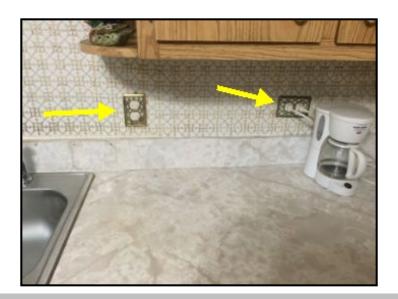
9. GFCI

• GFCI protected receptacles may not have been required when the house was built. I suggest buyer consider upgrading with GFCI's at all receptacles with in 6 feet of water sources.

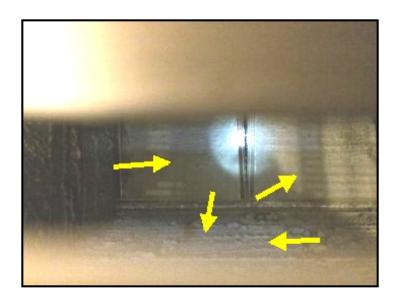
4. Filters

Air conditioner blower unit filters are dirty and the ducts are full of dust. I
was unable to access and inspect the blower unit in the attic for the air
conditioner. Although the fan did turn on when tested.

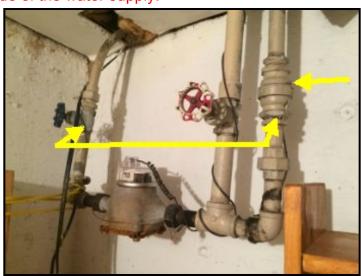
3. Miscellaneous

• There is no ground wire connected from the electrical panel to the water supply along with no bridging around from the street side to the domestic side of the water supply.

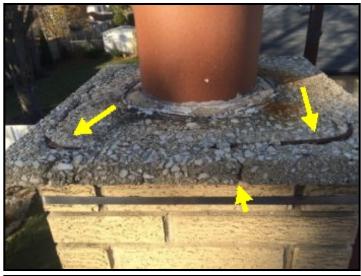
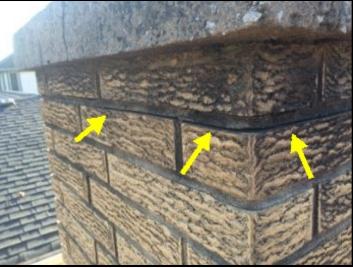
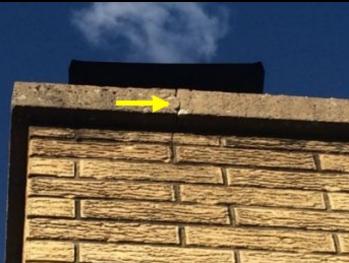
4. Miscellaneous

• The crown on both chimney stacks needs repair. There is rebar showing and cracks are present. This is cause the decay of not only the mortar but the brick as well.

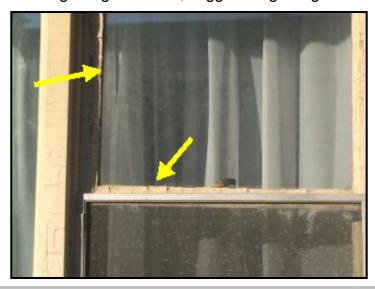
2. Window Condition

Broken glazing observed, suggest re-glazing as necessary.

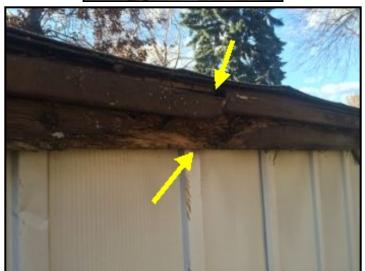
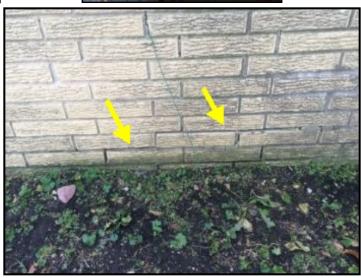
7. Miscellaneous

- The knee wall by the deck is showing sign of deterioration. The top is loose and athe wall mortar needs tuckpointing.
- There is mortar missing from the front sill which is causing the mortar to fall out on the stone below. i recommend filling these open areas.
- The shed wood surrounding the upper portion is rotted and should be replaced.
- The fence and gate are in need of some repair.

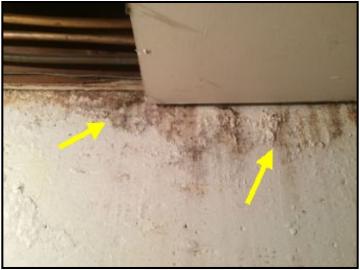
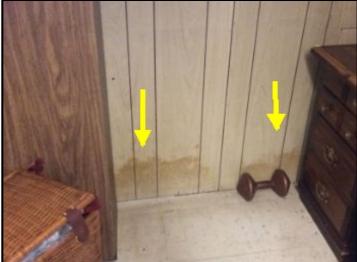
5. Miscellaneous

- There is water staining under the basement stairs on the foundation wall and on the west wall paneling.
 There are a few cracked glassblock windows

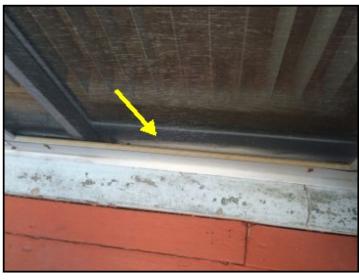
- The screen on the patio door is torn.There is a small water stain on the molding to the right of the door.
